Injector-Rehab.com

Injector p/n 4106	Vehicle Civic Si		Joe Example					
	Year 1993							
	Engine		1/1/2001					
	Injector #							
Test	1	2	3	4	5	6	7	8
Resistance ohms	11.9	11.9	11.8	11.9				
Leak Test Before	Pass	Pass	Pass	Pass				
Pass / Fail After	Pass	Pass	Pass	Pass				
Spray Pattern Before	Good	Good	Poor	Good				
Spray Pattern After	Good	Good	Good	Good				
Static Flow Before	282	279	243	276				
Static Flow After	279	276	274	276				
15 sec @ 3 Bar	69.75	69	68.5	69				
cc/min @ 3 Bar	279	276	274	276

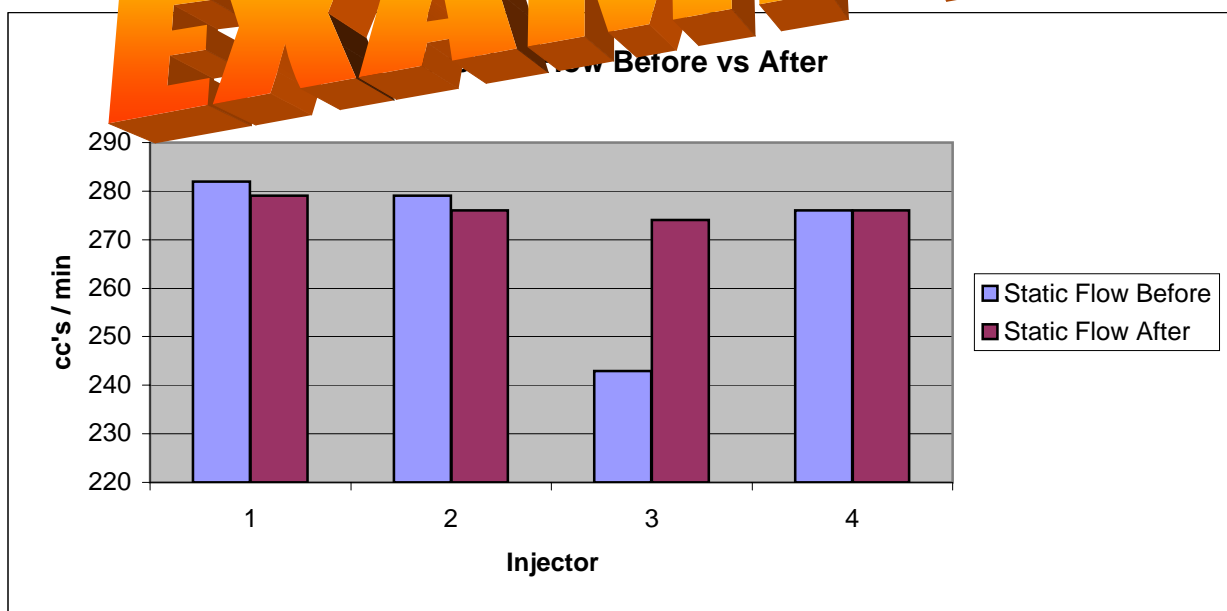
Largest Variance Before 13.830%
 Largest Variance After 1.792%

* Any percent variance under 2% is ideal.
